# Past SS2 DMX Issues

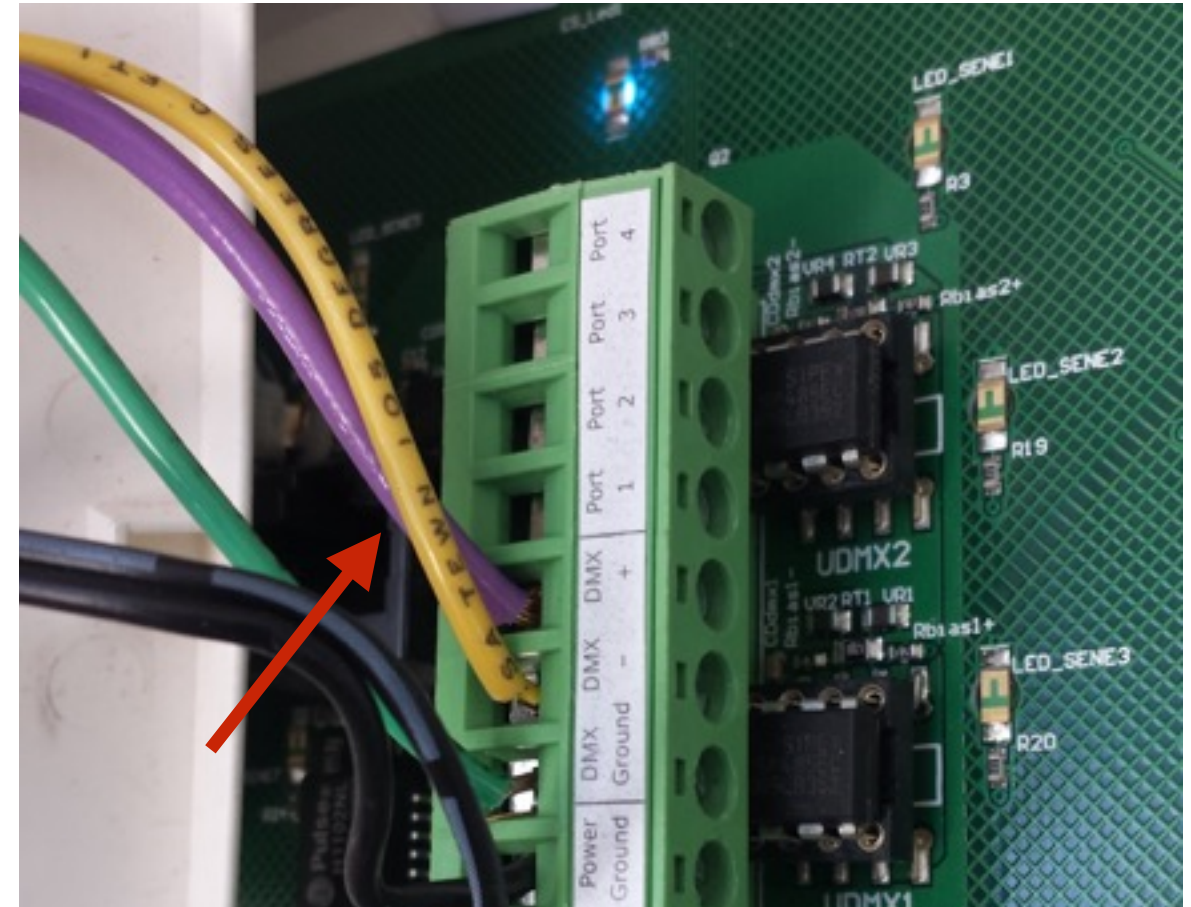
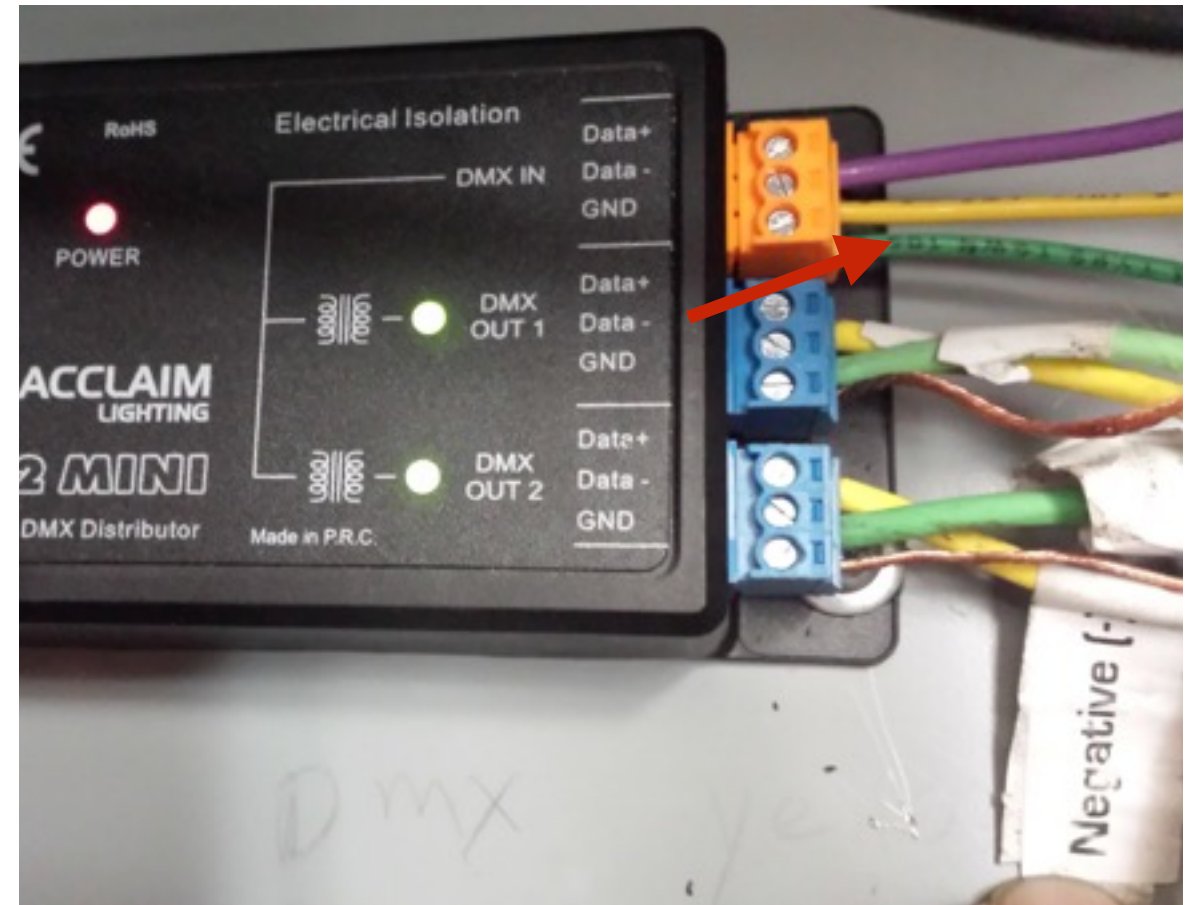
- DMX Wiring between controller and splitter - non-compatible wire type with USITT DMX512/A Standard
- Unknown termination location between 14/3 power cable and supplied Northwire DataCell 18/2 data cable coming into splitter enclosure

- Replaced with type: Northwire DataCell 18/2 Data Cable

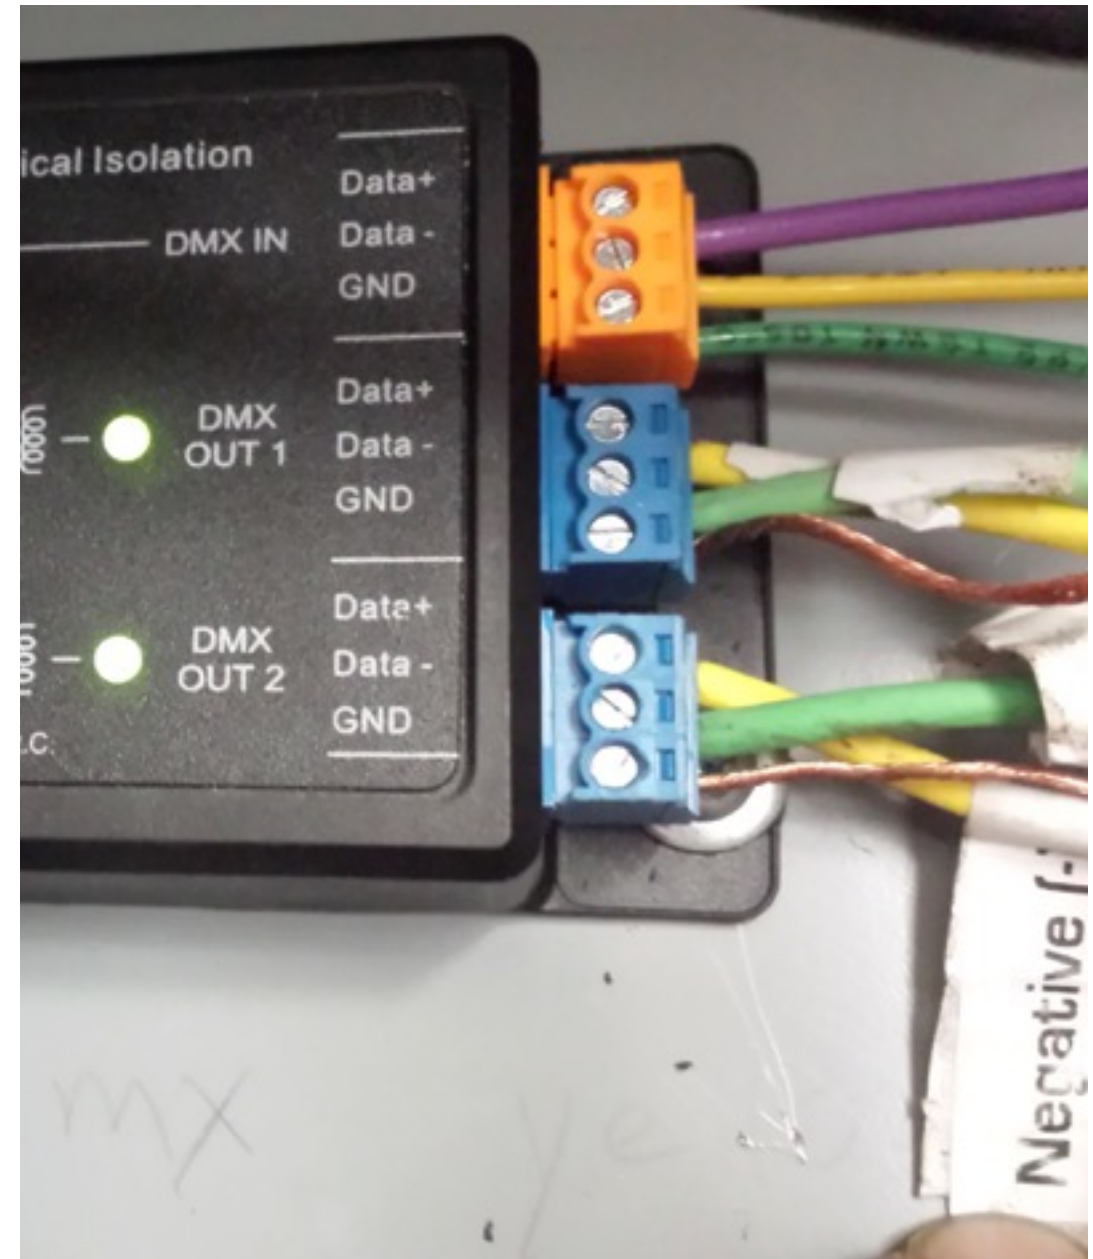
- Initial DMX output wiring has wrong polarity (green +, yellow -)

- Removed excess cable and properly terminated DMX output wiring

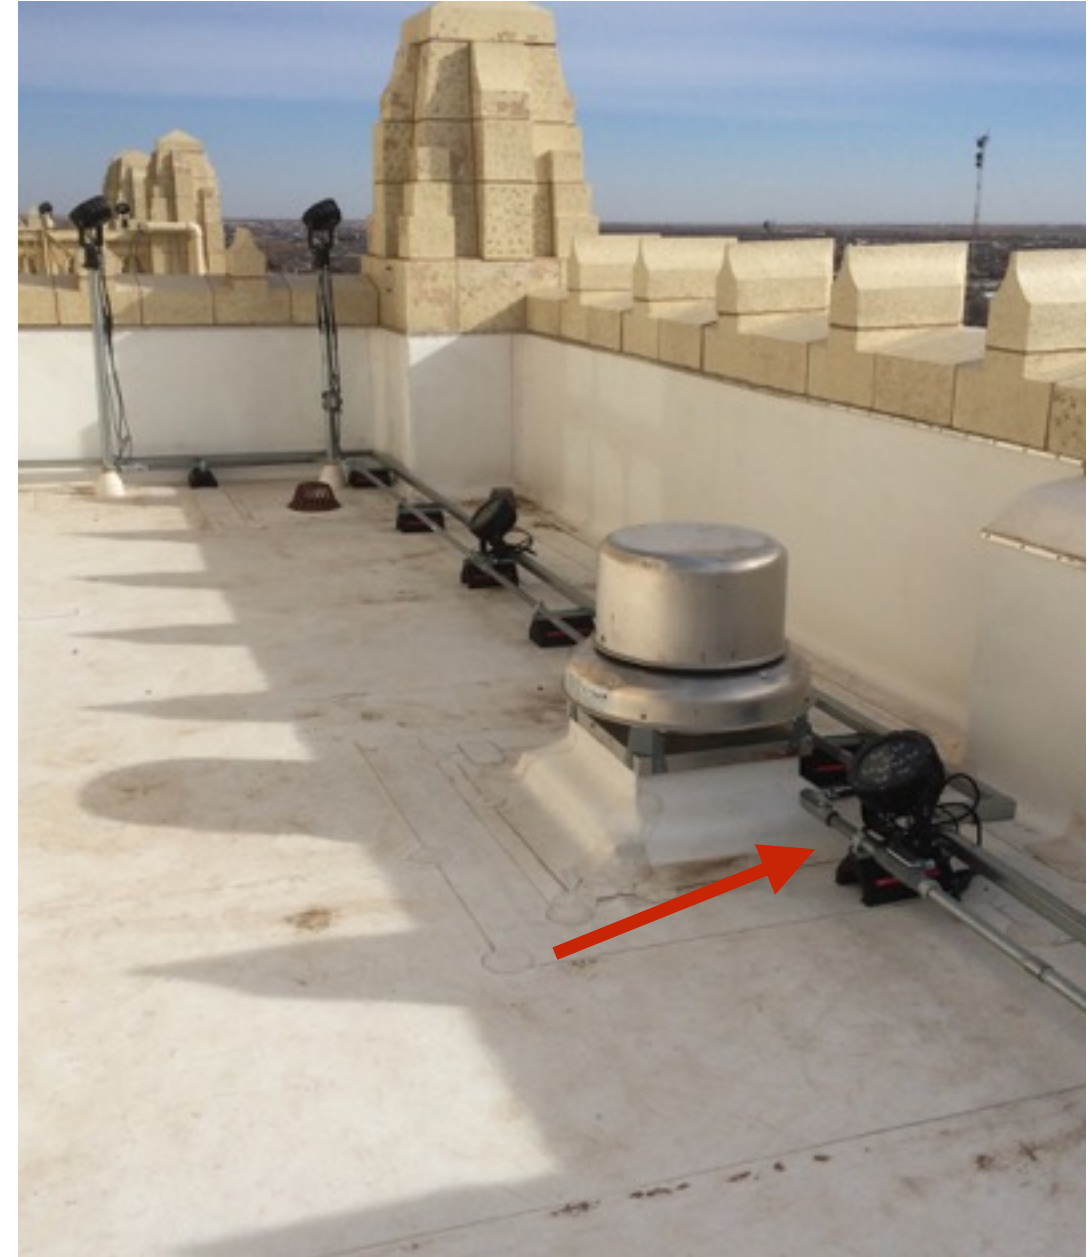
- Noted fixture would not respond to any set DMX address. Would output in "Slave Mode" starting on DMX address 1.

- Fixture was removed from DMX run
- Replace fixture and re-address to 13.

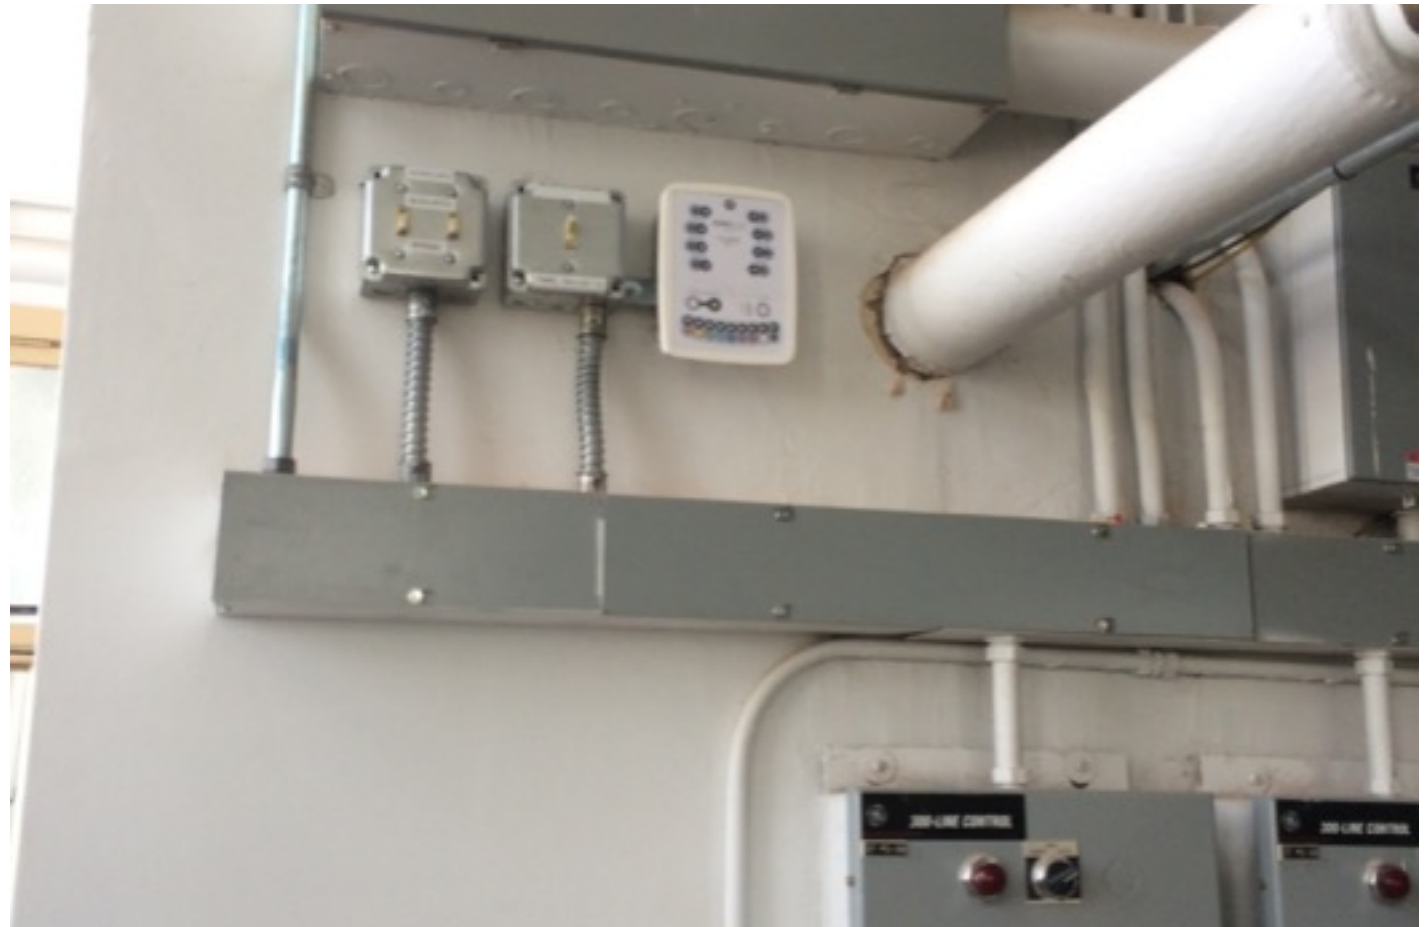
- DMX terminating resistor assembly - complete installation

- Fill with silicone for waterproofing and heat shrink assembly.

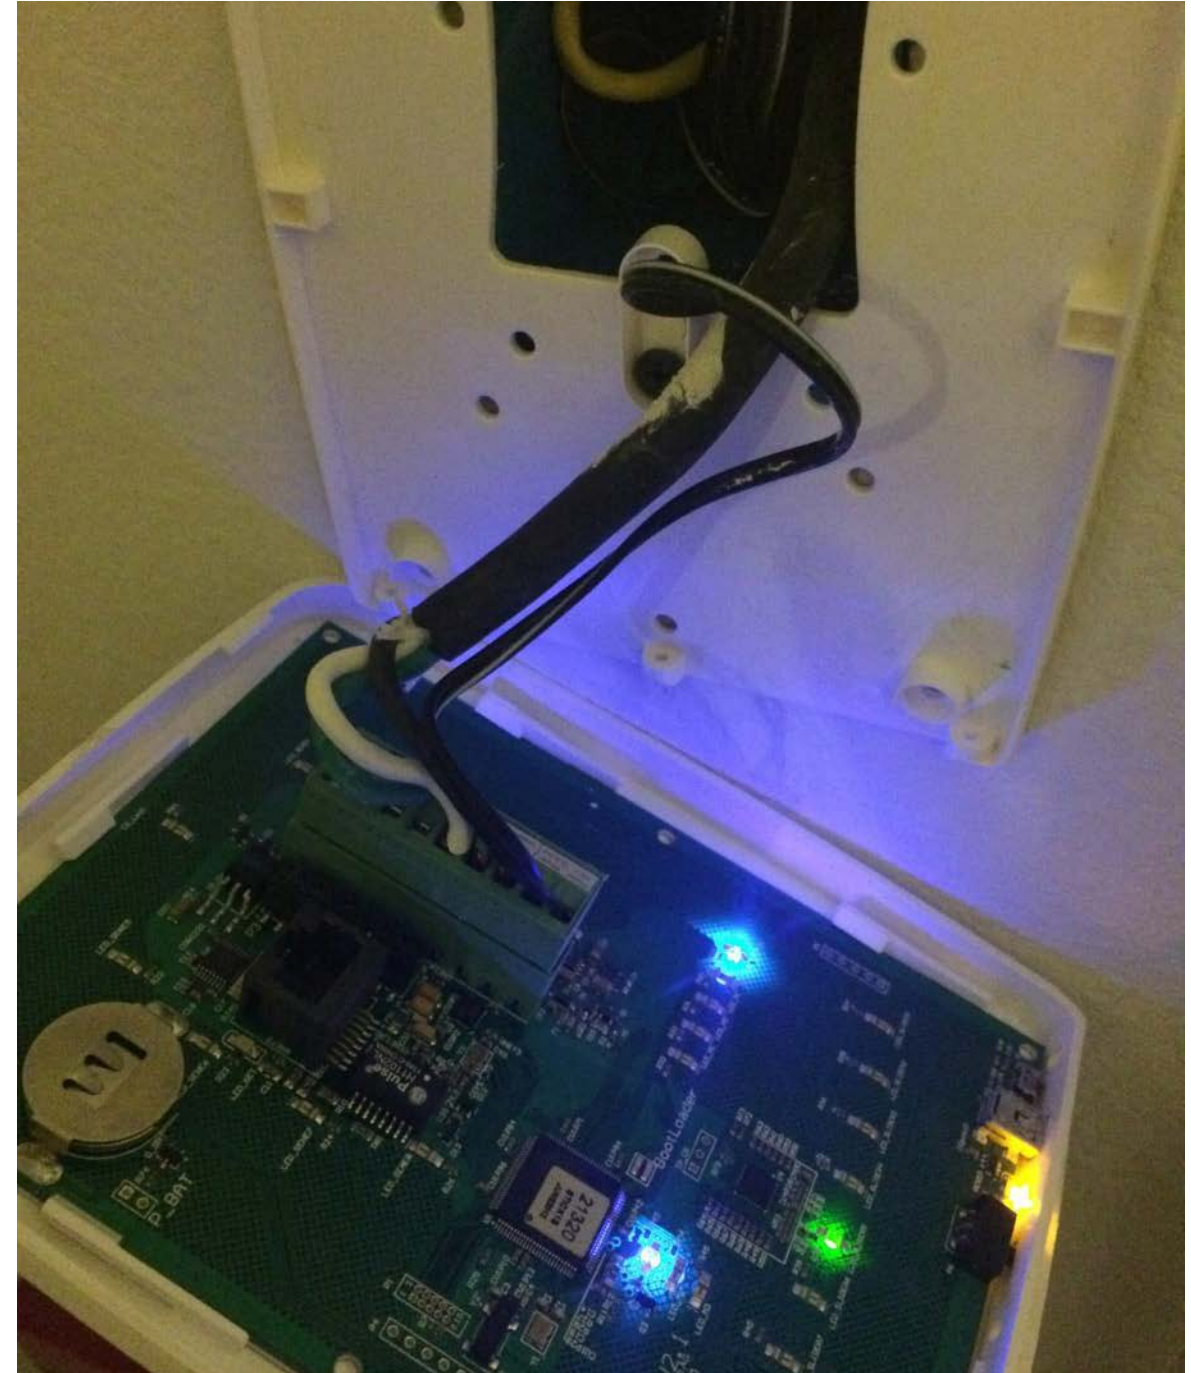
- Controller DMX output wiring is 14/3 power cable which is not DMX compatible

- Replace entire run with DMX compatible 120 ohm cable. Cat5e or better is a suitable alternative if inside metallic conduit. Color pinout would be as such:
  - White/Orange -> Data -
  - Orange -> Data +
  - Brown -> Data Ground

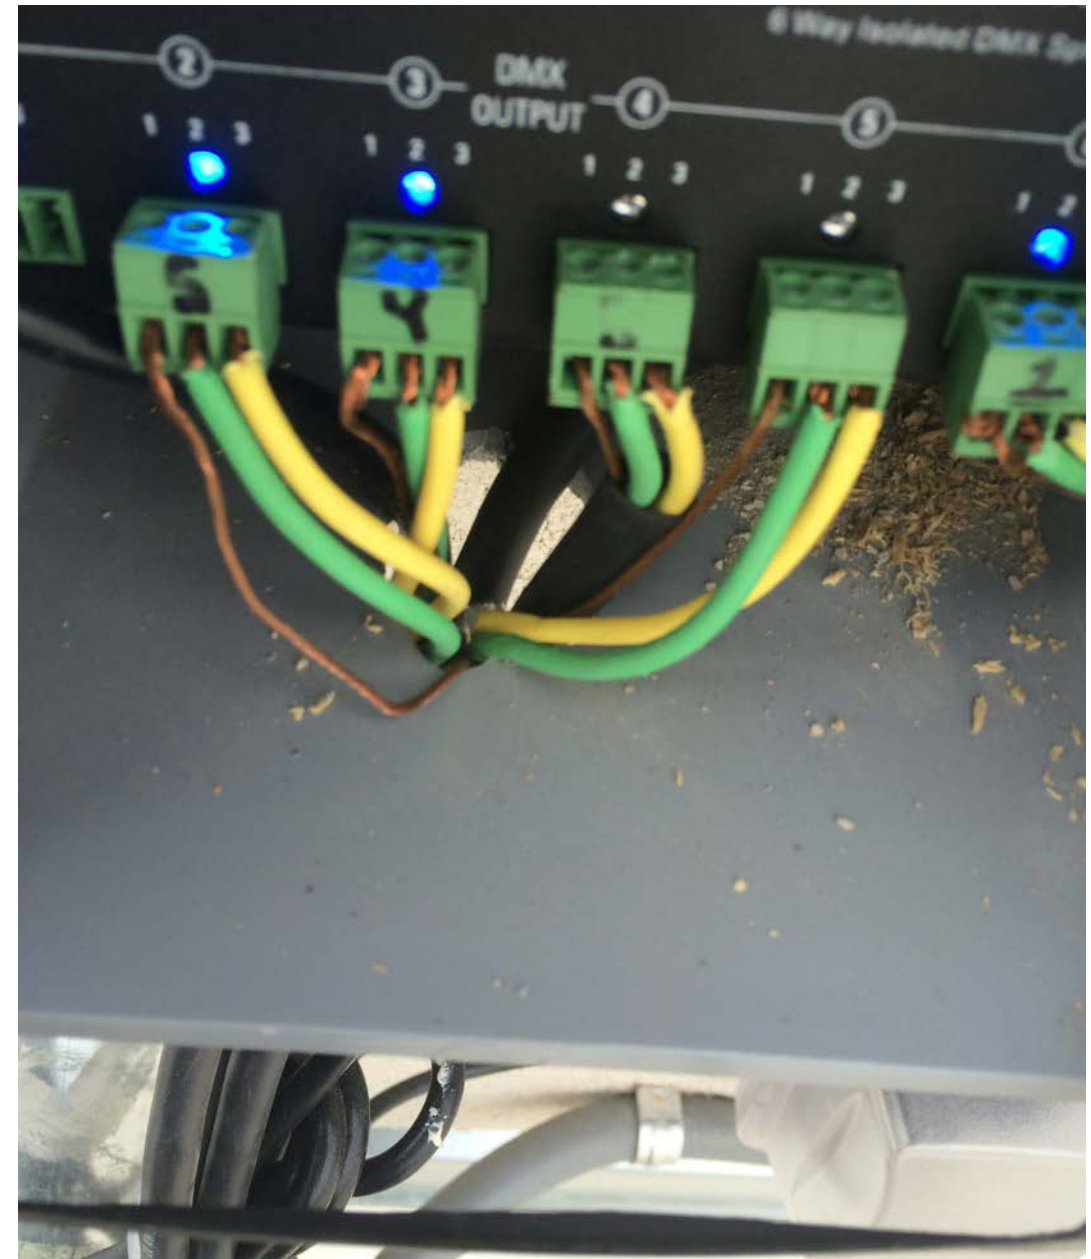
- Splitter enclosure has large hole in bottom where wires loosely feed into enclosure, possible moisture intrusion
- No cable strain relief, all weight of cables below are supported by Phoenix connectors
- Exposed copper shield wire and exposed copper in Phoenix connectors

- Replace enclosure with NEMA 4 rated enclosure
- Assuming individual cable runs, use water tight 1/2" cable grommet for each cable individually. Otherwise, run through conduit
- Use heat shrink for copper shield wires
- Ensure no copper wire is exposed when wiring into Phoenix connector

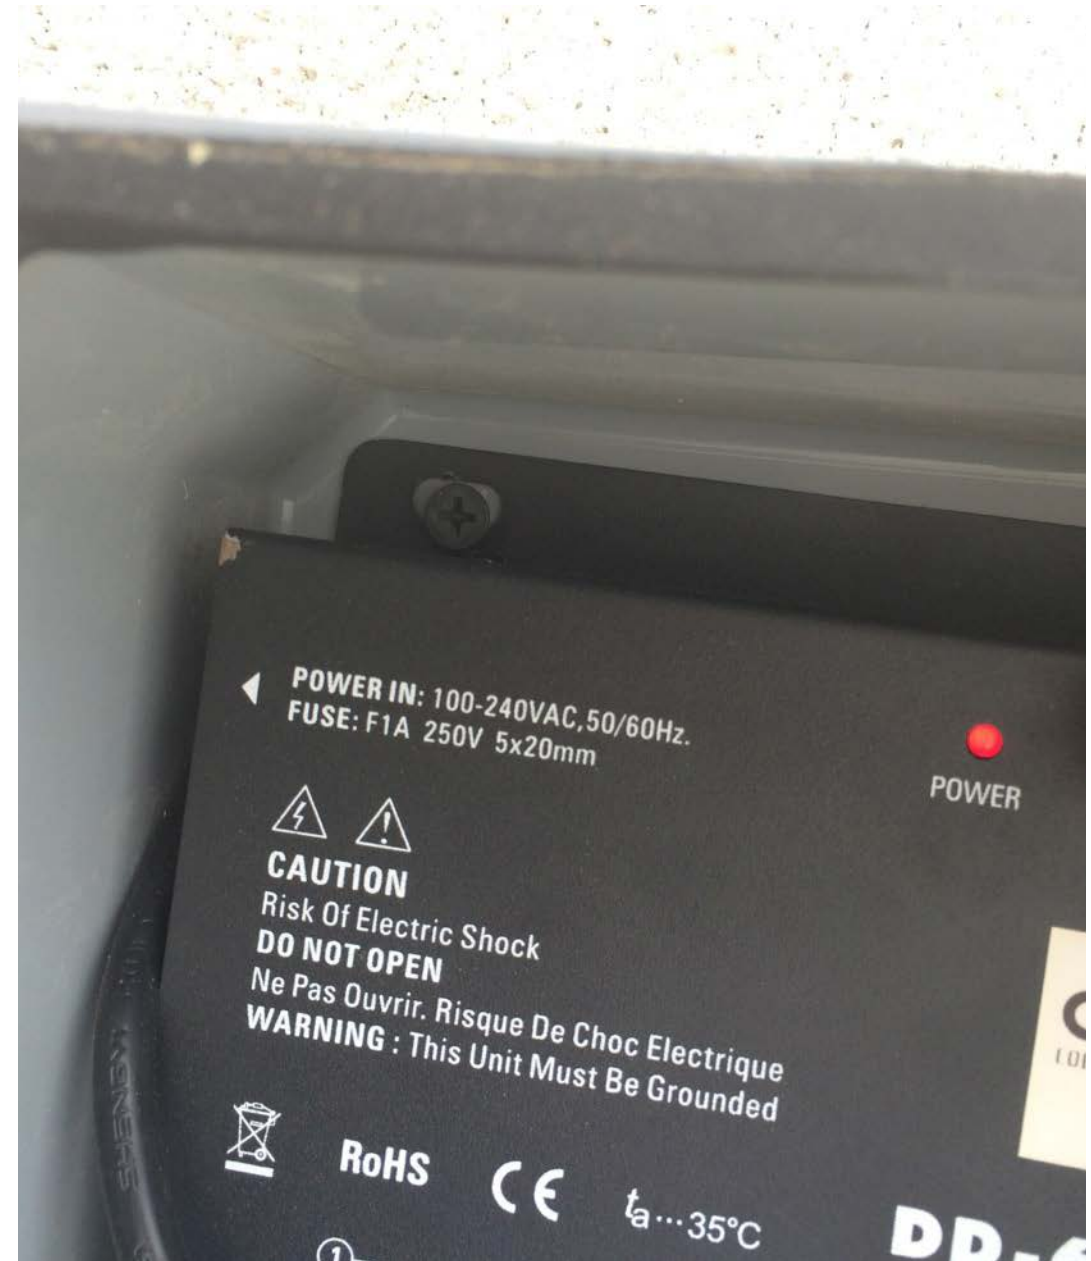
- Splitter mounted with drywall screws which penetrate through rear of enclosure

- Mount with alternative method to ensure moisture cannot enter enclosure

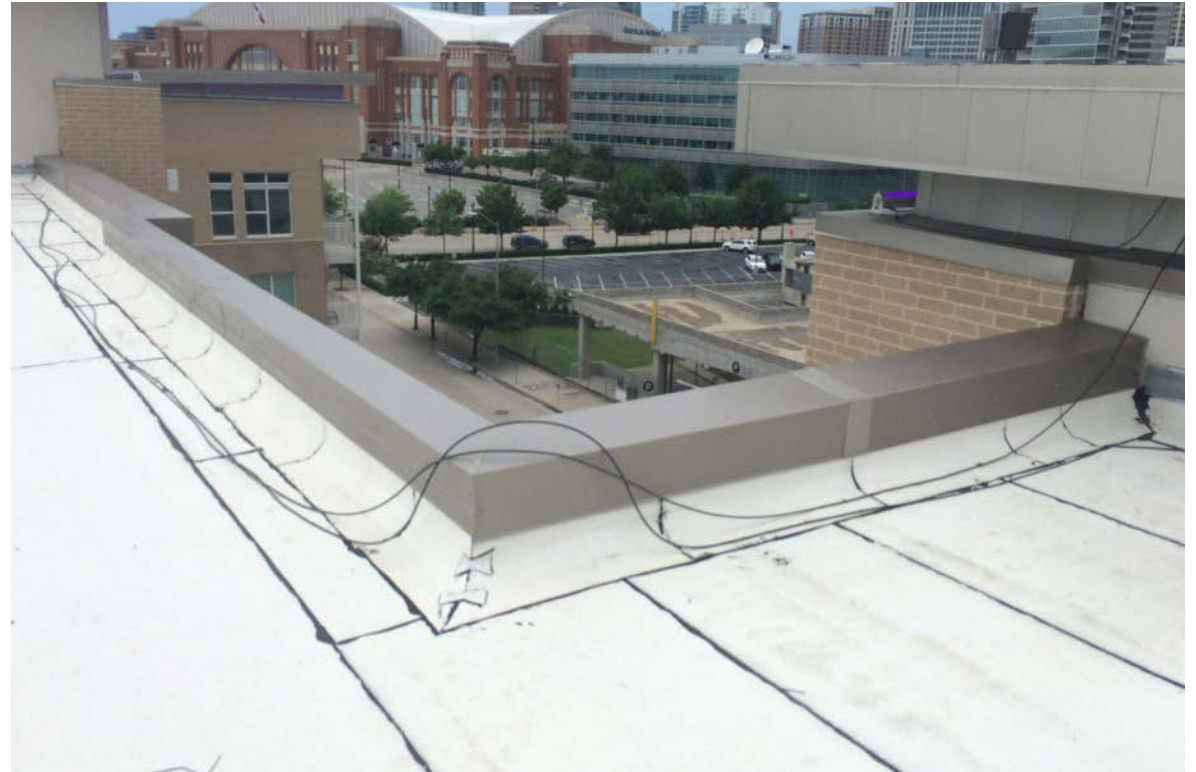
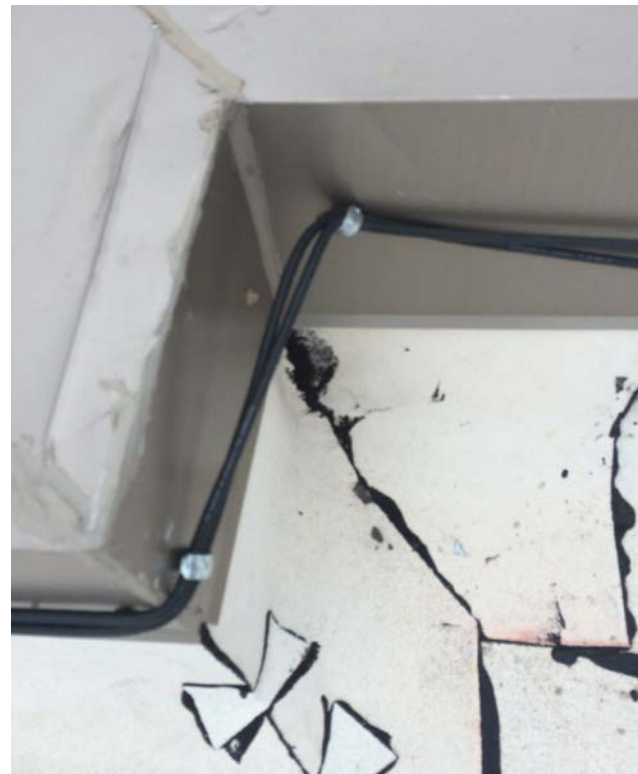
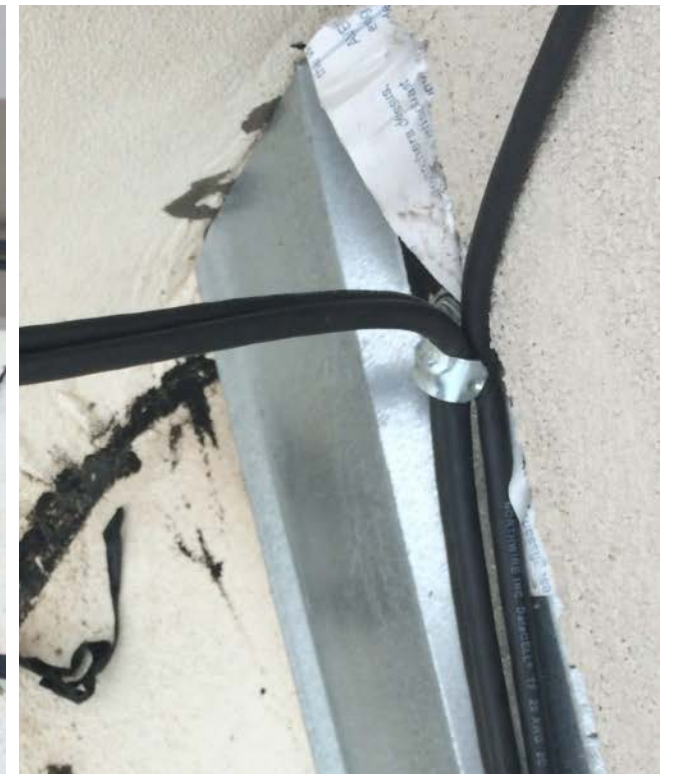
- Cable running along roof to right side is not fastened to structure
- Cable running along roof to left side is held too tightly against metal clamps. In the long term, cable jacket may become compromised or conductors could break

- Run all cabling in suitable sized conduit. With shielded wire such as the supplied Northwire DataCell 18/2, pvc would be acceptable. Should wire be switched out to Cat5e or better, EMT is recommended to aid in noise rejection and shielding
- Use clamps in parallel along wire run to avoid sharp 90° turns. Conduit preferred as it will have diameter bends.

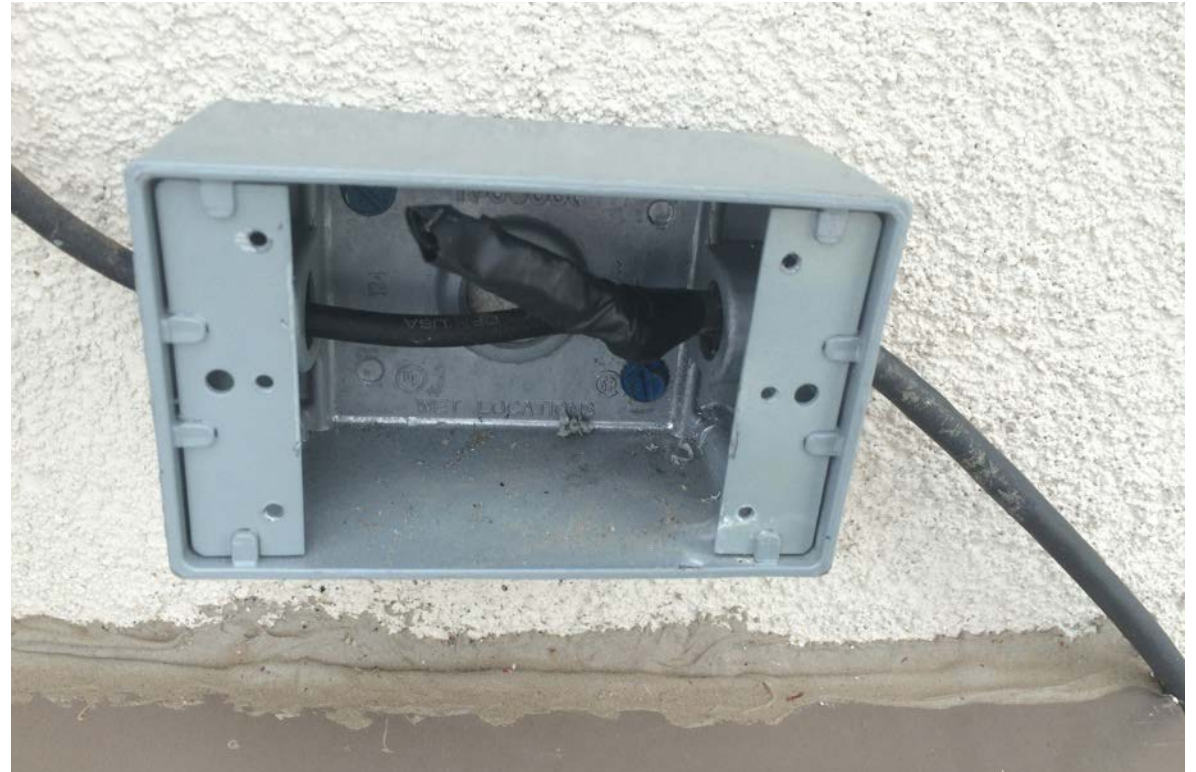
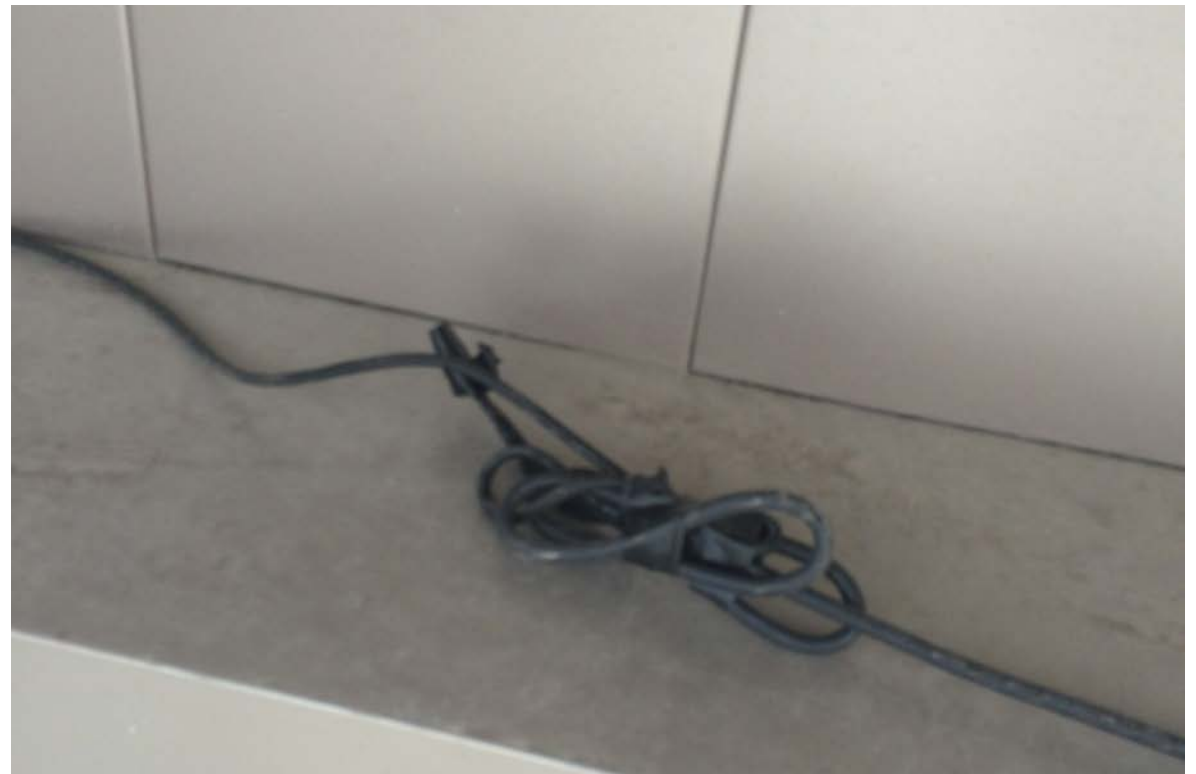
- Metal single gang boxes on right side towers only and do not have adequate waterproofing nor cable grommets
- Two towers on left didn't have boxes and had electrical taped terminations.
- No service loop in case of termination failure

- Use 1/2" weather proof cable fittings to ensure water tight connection
- All terminations should be enclosed in a water tight enclosure

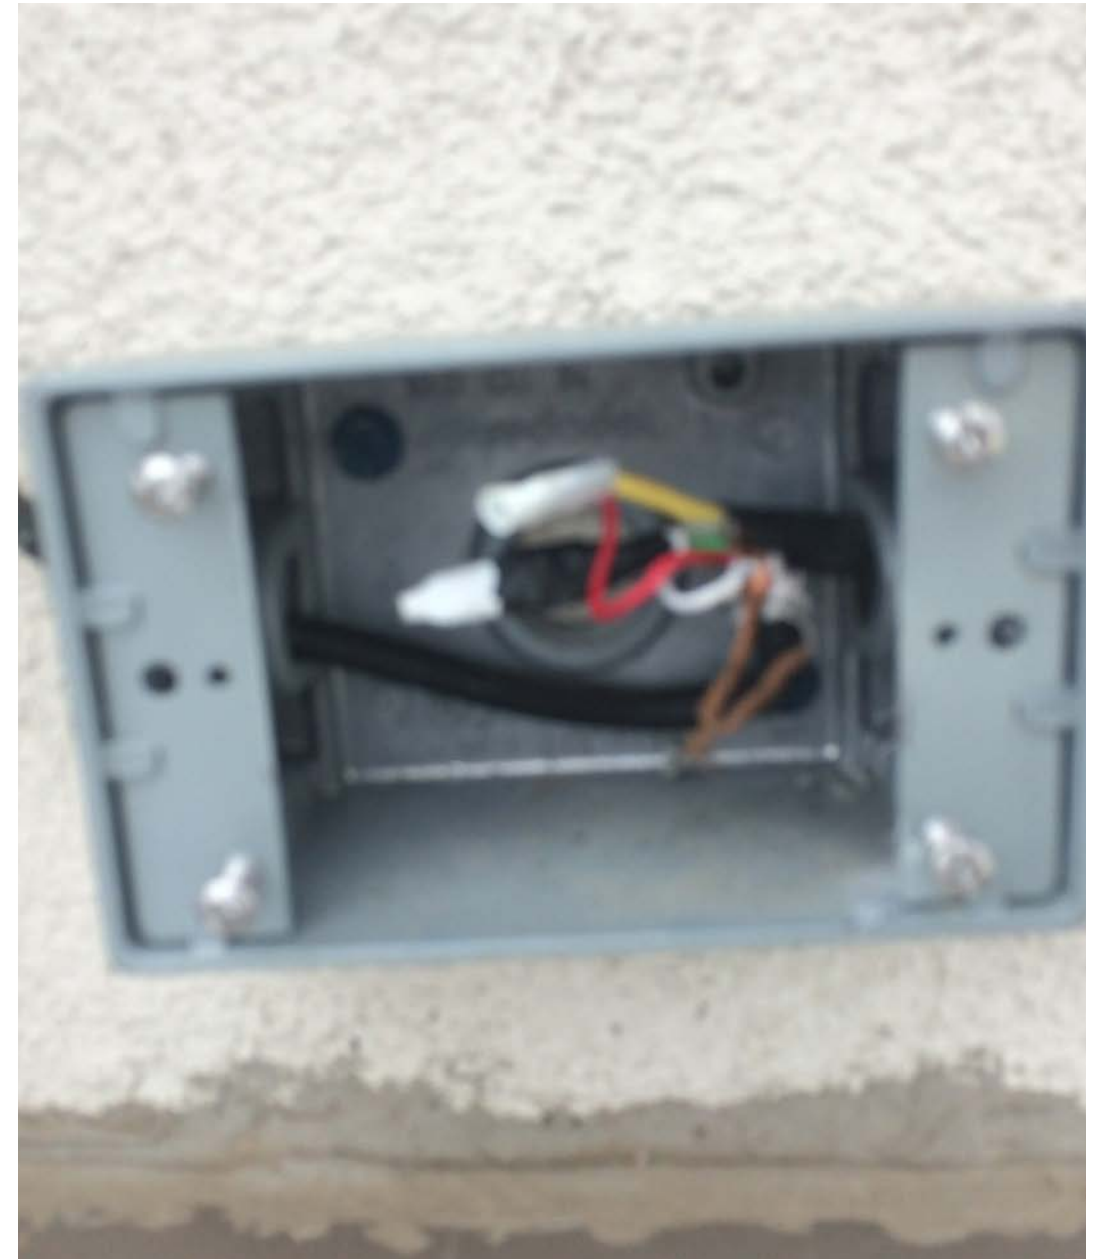
- Terminations used non-water tight crimp connectors
- Exposed copper shield wire
- Not enough cable to re-do termination

- Solder wires together and use heat shrink over terminations or use gel filled connectors
- Heat shrink copper shield wires
- Include approximately 6" of length of wire as service loop

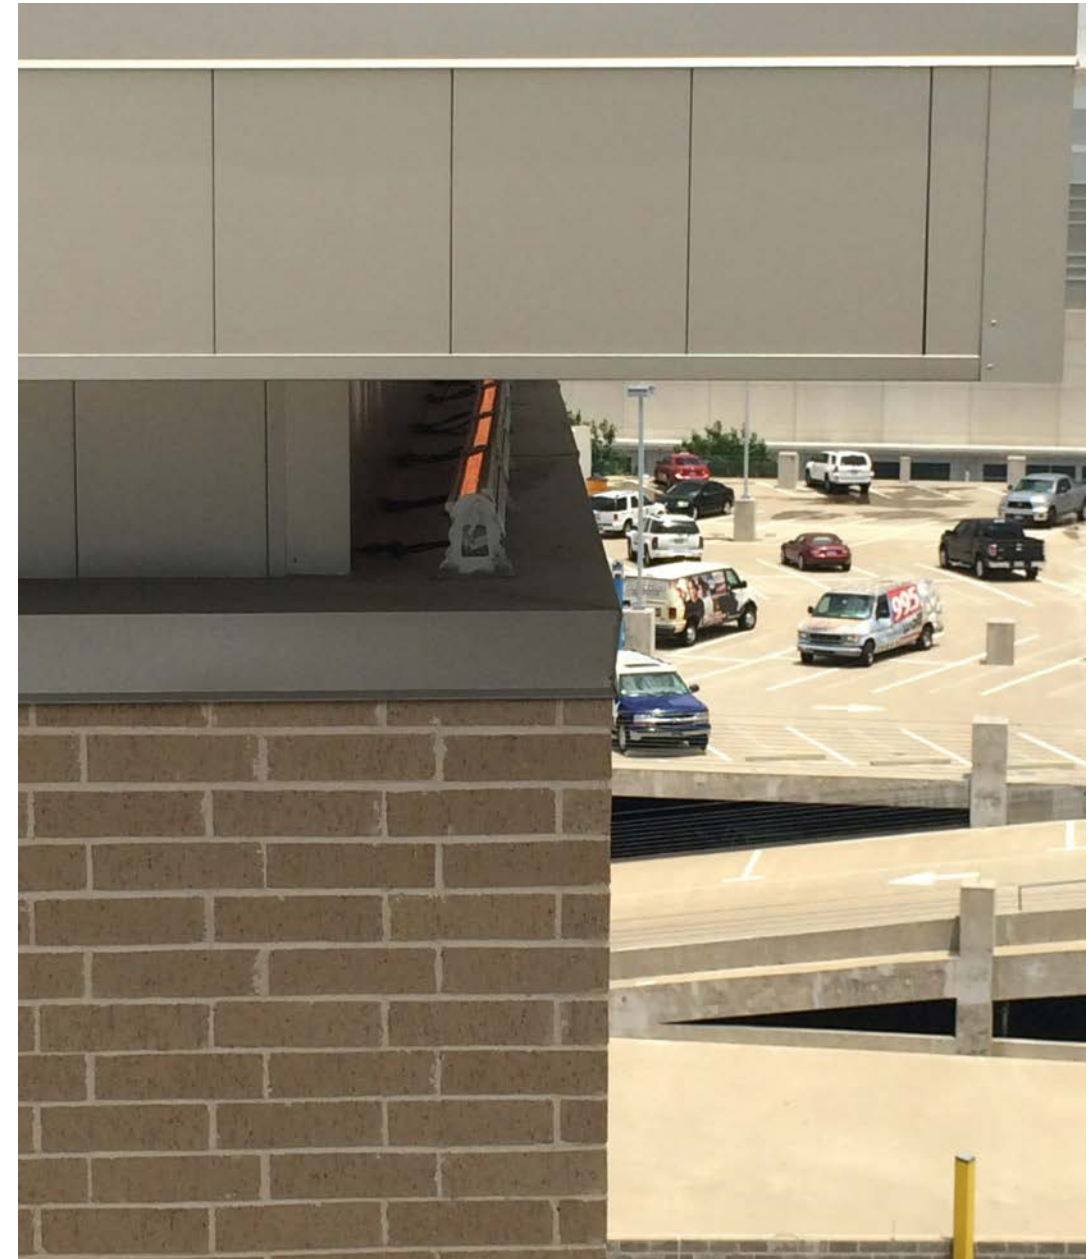
- Some fixture runs looked to have more than 8 fixtures per power lead

- Ensure that there are no more than 8 fixtures per fixture power lead
